ADDENDUM NUMBER: Addendum - One

PROJECT TITLE: County Correctional Facility South
HOC Dormitory Roof Replacement and Repair
Site Number: 295
Building Number: 590 and 612
8885 South 68th Street
Franklin, Wisconsin 53132

PROJECT NUMBER: J063-14432

ROOF CORE SAMPLE REPORT

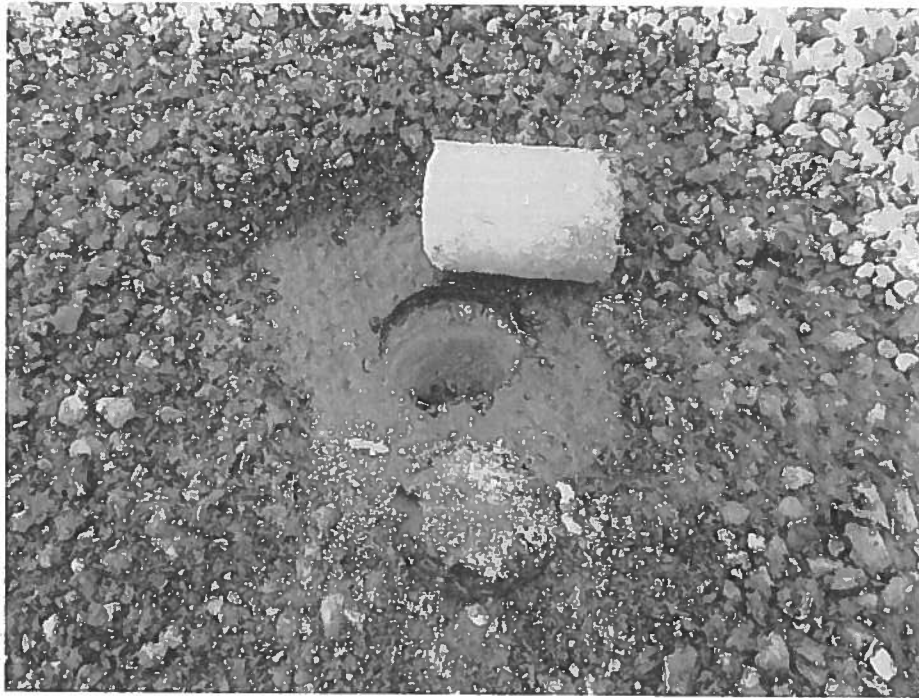
We inspected the two roof areas noted on the drawing below. We found open splits on both roof sections. In our opinion these roofs area prematurely failing due to installer error. We performed a core sample at the drain on both roof areas. Our cores revealed .25" of built up roofing, 3" of light weight concrete insulation over a concrete deck.

Core sample

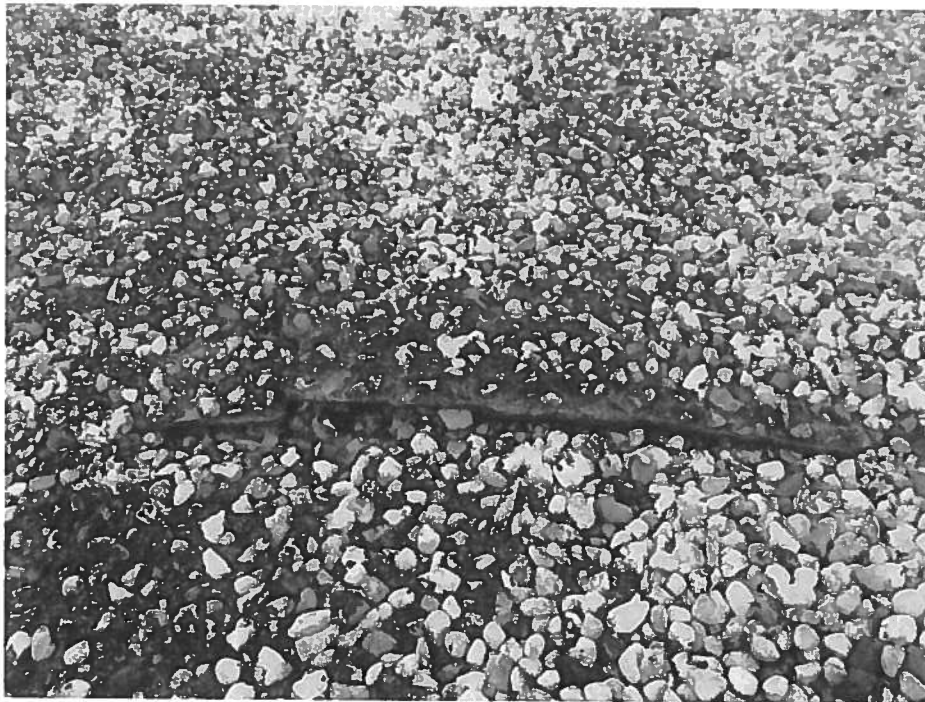
Typical split in roofing
